MARINE INVESTIGATION REPORT  
M01M0100

SWAMPING

SMALL FISHING VESSEL *ALAIN-JOSÉE*

05 SEPTEMBER 2001

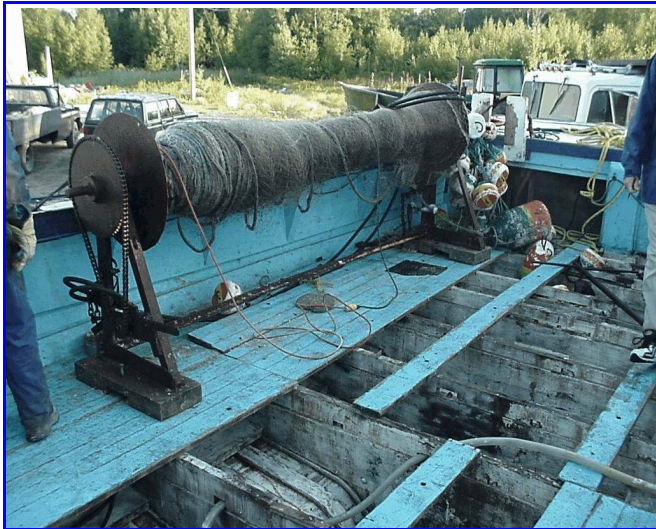
Photograph 2. Net Drum (Starboard Side)

A hydraulic net drum winch is located along the starboard gunwale where the empty gill-nets are launched and set (see Photograph 2). The loaded nets are then retrieved over the port side and across the well deck, where the herring is systematically shaken from the net onto the open deck. The emptied net is then stowed on the drum, ready to be launched again. Several gill-nets may be set during the course of a fishing cycle.

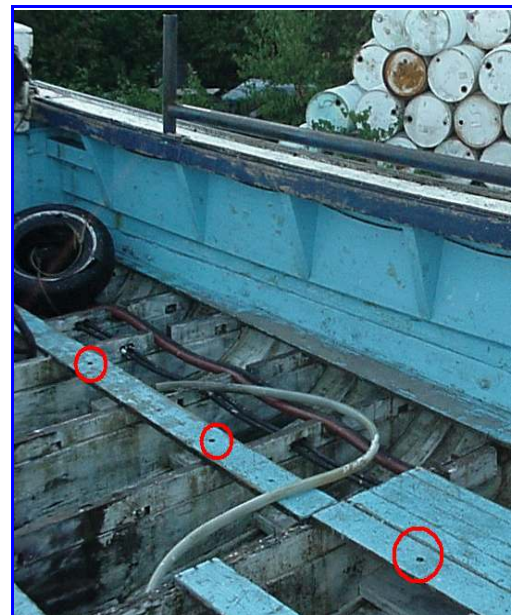
Photograph 3. Drain holes in deck

Water which accumulates on deck while fishing is drained into the bilge through holes in the well deck planking (see Photograph 3). The  $\frac{3}{4}$  inch holes, distributed at intervals on the well deck, are considered, from experience by the owner/ operator, to be adequate to drain water encountered during normal fishing operations.

The deck drainage system may work adequately when handling lobsters or shellfish. During the occurrence, with a dense load of herring on deck, the fish covered the small and widely spaced drain holes. This prevented a large quantity of shipped seawater from getting down to the bilges, where it could be pumped out.

When a wave washed over the stern of the *Alain-Josée*, onto the well deck, an attempt was made by the crew to shovel some of the fish over the side, but without success. The gasoline-powered pump in the wheelhouse was started, but reportedly, there was no water in the bilge to pump and the unit was shut down. The accumulated water on deck was impeded from draining by the mass of fish covering the drain holes in the deck planking.

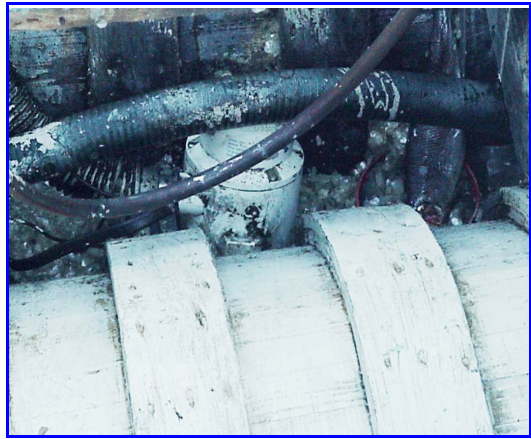
Photograph 4. Electric bilge pump

Drained bilge water is normally pumped over the side by an electric, automatic, submersible bilge pump, model “Rule 3700GPH” (see Photograph 4). It is installed aft of the main engine, secured near the bottom of the hull at one side of the propeller shaft tunnel.

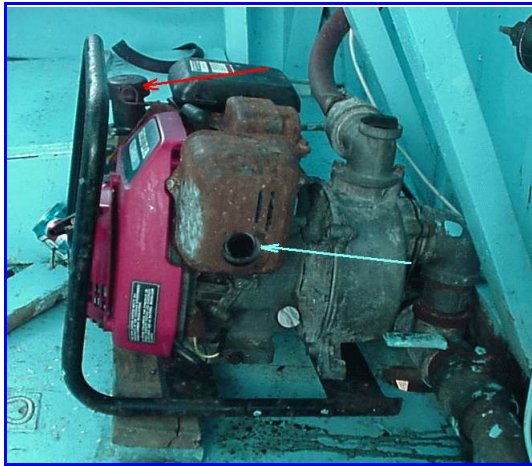
Photo 5a. Gasoline powered pump

When the electric bilge pump cannot cope with the inflow of water, a gasoline-powered pump, model Honda WN20, located in the wheelhouse, is used to pump the bilges of excess seawater (see Photograph 5a). One side of the lifting cradle for the once-portable Honda pump had been removed and the unit is wedged tight onto the deck, inside of the rear bulkhead of the wheelhouse. The pump’s gasoline engine exhausts directly into the wheelhouse, where fuelling of the unit by hand also takes place. This poses the risk of asphyxiating the operator conning the vessel and/or causing a fire within the compartment.

1. The gasoline-operated bilge pump exhausted into the wheelhouse and the fuel filling spout was also within the compartment.
2. The gasoline-driven pump is of a type not recommended for use with sea water.
3. Owners of Cape Island type fishing vessels may be unaware that loading heavier catches, with corresponding decreases in freeboard, may place the vessel in a condition unfit for its intended purpose.
4. The crew was not wearing lifejackets.

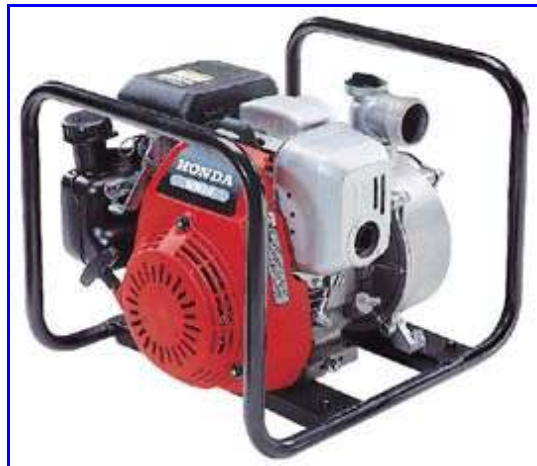
Photo 5b. Honda Pump

Honda portable pumps (see Photo 5b) have given rise to safety issues in the past, as referenced by TSB investigations M97M0005 and M97N0099.<sup>3</sup> Due to their dissimilar metal components, and galvanic corrosion problems, these pumps are not recommended for use with sea water. A Ship Safety Bulletin (SSB 98-04) was issued by TC relating to the suitability of portable pumping equipment for the marine environment. The owner/operator reported having heard of Ship Safety Bulletins, but had never received one.

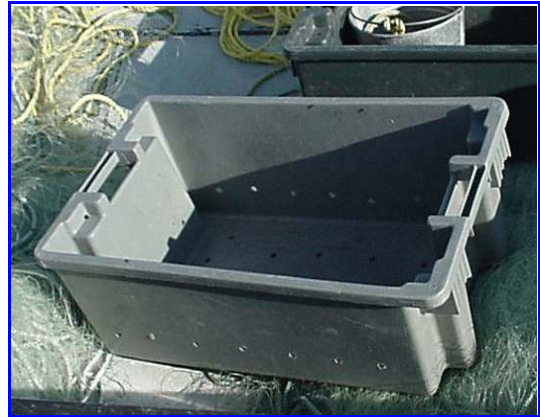
Photograph 6. Typical fish box

Of the 9 tonnes of herring brought on board the *Alain-Josée*, only 7.5 per cent of the total catch was contained in secured fish boxes (see Photograph 6). The bulk of the herring (8.4 tonnes) was loose on deck, free to move as the vessel pitched and rolled. Unlike some other open-decked herring boats, the deck of the *Alain-Josée* is not equipped with portable wooden pen boards, which are slid into vertical stanchions attached to the deck and at the perimeter of the well deck. These pen boards are arranged such as to divide the well deck both longitudinally and transversely into small penned areas to contain the catch, thus dramatically reducing the movement of the herring on deck. Had such an arrangement been used on the *Alain-Josée*, it would have increased the vessel's stability and improved its behaviour at sea.
